Corrosion in the Flue Gas Cleaning System of a Biomass-Fired Power Plant

Published in:
Journal of Failure Analysis and Prevention

Corrosion in the flue gas cleaning system of a biomass fired power plant

Abstract

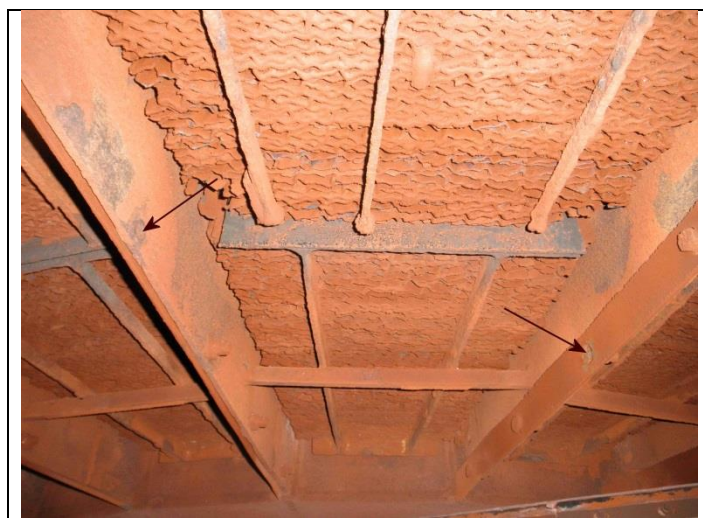
After 15000 hours of operation, significant corrosion damage was observed in the lower part of the GGH closest to the centre of the rotor (Figure 2). Here there was up to 2 mm metal loss and many of the UNS S31600 bolts had failed leading to the unfortunate consequence that radial sealing strips had been found further on down the system in the duct before the booster fan. There were also large amounts of spalled rust in the ducts after the GGH which had originated from the GGH rotor. In addition there were deposit agglomerates of unknown composition or origin. In some cases there was the appearance of “wet” corrosion products when the FGCS was inspected during downtime.

Figure 2 shows the lower part of the gas-gas heat exchanger where severe corrosion was observed. Oxide had formed on the frame of the rotor fabricated in weathering steel. Some UNS SS31600 bolt heads had ruptured (as shown by the arrows) which had resulted in detachment of the UNS N10276 sealing strips.

Figure 2: Photo of lower part of gas-gas heat exchanger where arrows indicate missing bolts.

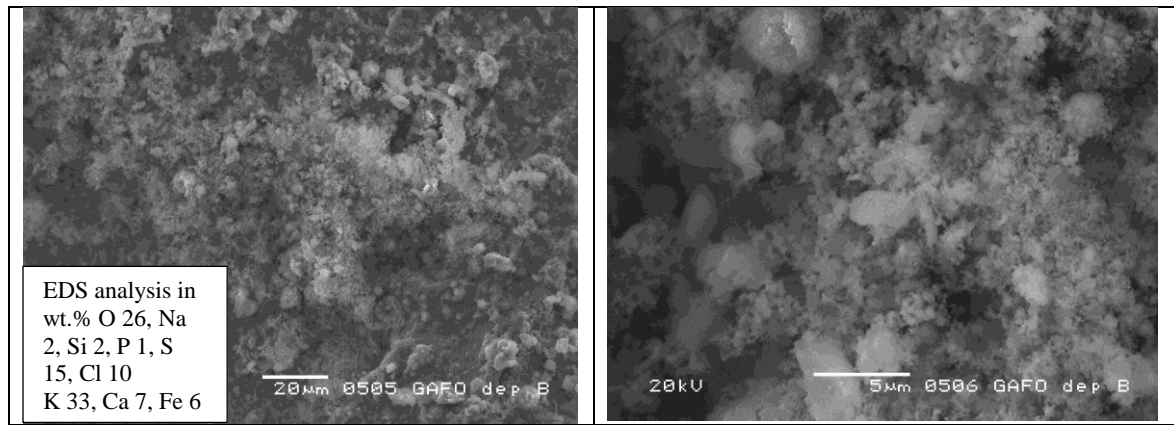
Fine white powder was observed at the top of the GGH and in the DeNO_x unit. If more straw had been fired in the time period preceding inspection, then more “white powder” was observed. These particles have the morphology and composition as shown in Figure 3, and with XRD, the phases KCl (sylvite JCPDS 41-1476), K₂SO₄ (arcanite JCPDS 70-1488) and K₃Na(SO₄)₂ (JCPDS 74-0398) have been identified. Neither ammonium chloride nor ammonium bisulphate was detected. Wet analysis was undertaken to investigate the presence of ammonia compounds as described in [4] but only trace amounts were detected. Similar sized submicron particles were also present in other areas after the FGD and were also present in the crevice between the sealing strips and weathering steel rotor. The micrograph to the right reveals submicron particles.

Figure 3: SEM-EDS analysis of fine particles typically found in GGH and DeNOx unit.

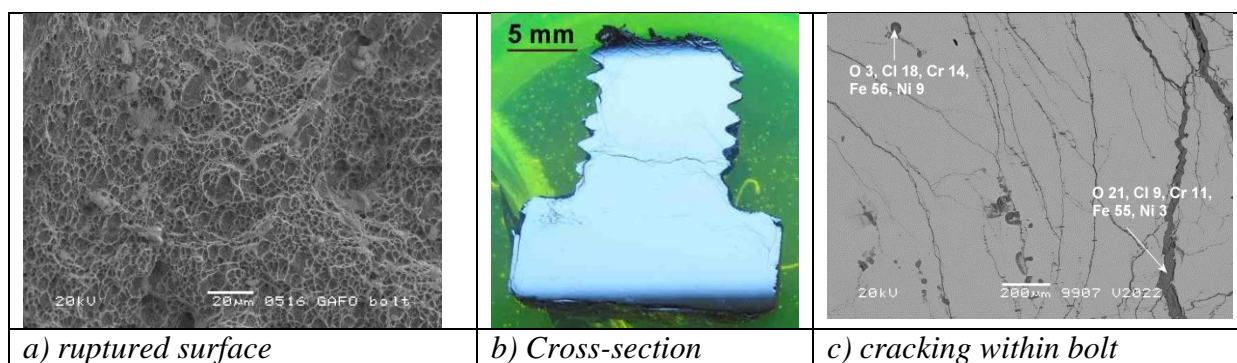
One of the ruptured bolts was examined on the fractured surface with SEM-EDS and revealing an equiaxed dimple structure. Particles containing K, Cl, S, and O were also present in these areas Figure 5a. The bolt was also cut longitudinally and examined with LOM and SEM-EDS (Figure 5b and c). There were many cracks in the bolt and analysis at the bottom of the thread revealed high content of chlorine, some sulphur, but only traces of potassium and calcium.

Figure 5: Failed stainless steel bolts revealing widespread cracking. Analysis in wt. %.

The corrosive species detected within the bolt were predominantly chlorine and oxygen together with the constituents of the stainless steel. In addition traces of sulphur could be detected. As can be seen from the crack morphology, there is transcrystalline attack and chlorine was detected within the cracks. A bolt was also removed from the middle part of the GGH weathering steel rotor where there was less visible corrosion. The corrosion attack that was most prevalent for the bolts was pitting corrosion approx. 50 μm deep (Figure 6).

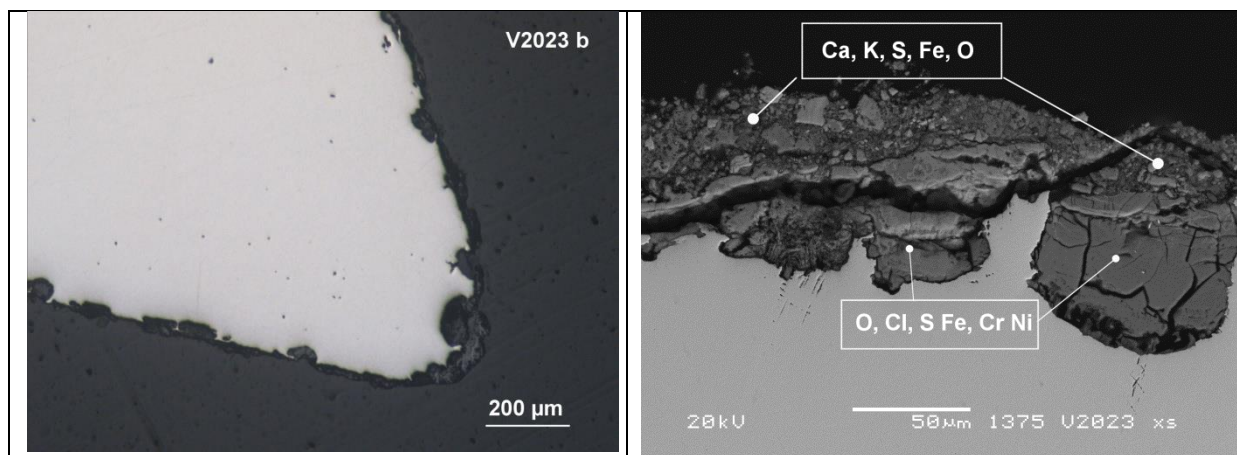
Figure 6: Analysis of a bolt (not ruptured) from the middle of the GGH. Analysis in wt. %

There were occasional cracks present however not to the extent that the bolt would risk rupture. The chemical composition of the corrosion products within the pits revealed by SEM-

EDS was potassium and calcium on the outer side closest to the flue gas and chlorine and sulphur within the corrosion product closest to the metal.

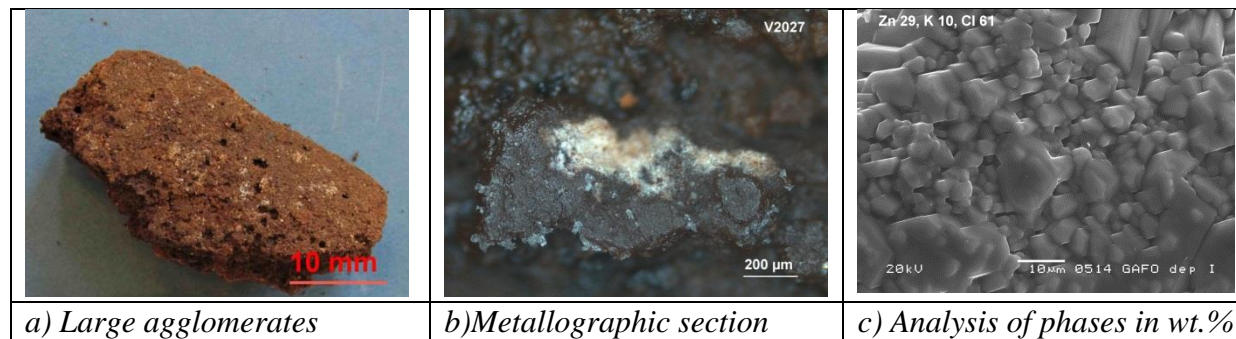
A large amount of spalled oxide was observed immediately before the booster fan which had the same composition and appearance of that found in the GGH. The fact that deposits/oxides accumulated in this area could be due to a 90 degree bend in the duct before the booster fan, but also due to the presence of the booster fan in the duct as a physical hindrance to large airborne particles. The transportation of these spalled oxides from the GGH also result in erosion of the booster fans blades. In addition large deposit agglomerates were found here in the initial years of service. One of these agglomerates is shown in Figure 7a and it was clear that these deposits were difficult to prepare for analysis as they were very hygroscopic (Fig. 7b). Analysis of these deposits with SEM-EDS in Figure 7c revealed the presence of Zn, Cl and K.

Figure 7: Analysis of large agglomerates found in the duct after the GGH.

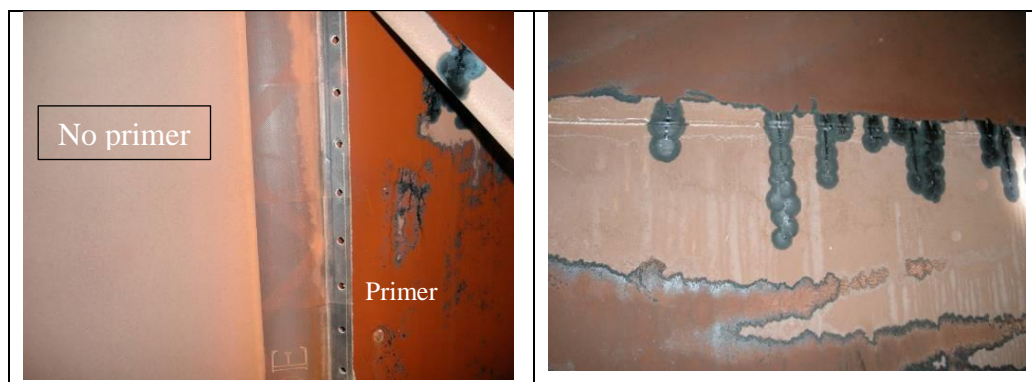
During inspections in 2013 and 2014, in some areas the protective primer was still visible, and in other areas this coating had been removed by corrosion/erosion. Figure 8 compares two different locations in the FGCS after the GGH showing the red colour of the primer and what is observed at the interface. Figure 8 (left) shows two areas of the duct adjacent to one another where primer was and was not used. Some pitting attack of the primer is observed exposing the underlying material. Figure 8 (right) from the silencer shows the interface between coating and non coating, where a black fluid was seeping out.

Figure 8: Duct before booster fan (left) and duct before silencer (right).

There was a difference in appearance between components with a primer coating and those without. Those without a primer coating exhibited general corrosion. For structures coated with a primer, in some places it was observed that there was no primer as this had been removed due to corrosion and erosion. At the interface between the original primer surface and the steel surface, a black compound was present, which was hygroscopic during shutdown, had an acidic pH and was rich in Zn and Cl. $ZnCl_2$ products are more hygroscopic than iron chlorides or KCl [3]. Especially during shutdown as the temperature decreases below the dewpoint, pitting corrosion can occur where hygroscopic deposits are present, because of the localised high concentrations of chlorine and low pH. It is not known whether the coatings result in reducing or increasing corrosion rates, however they can give an appearance of increased attack. The primer probably reduces corrosion during the first years of operation, however when the coating is broken down and the Zn in the coating starts to react with the HCl, or KCl, then localized pitting attack will occur.

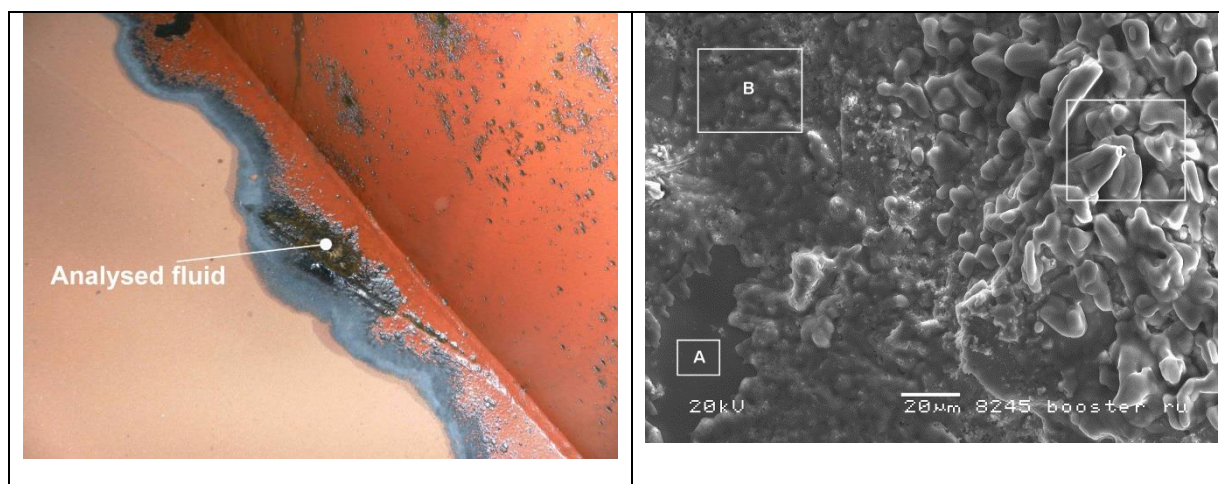
O	Cl	K	Fe	Zn
A	31	34	11	9	16
B	14	43	16	8	20
C		54	18	2	27

Figure 9: SEM-EDS analysis of liquid from booster duct where Zn primer had been used.

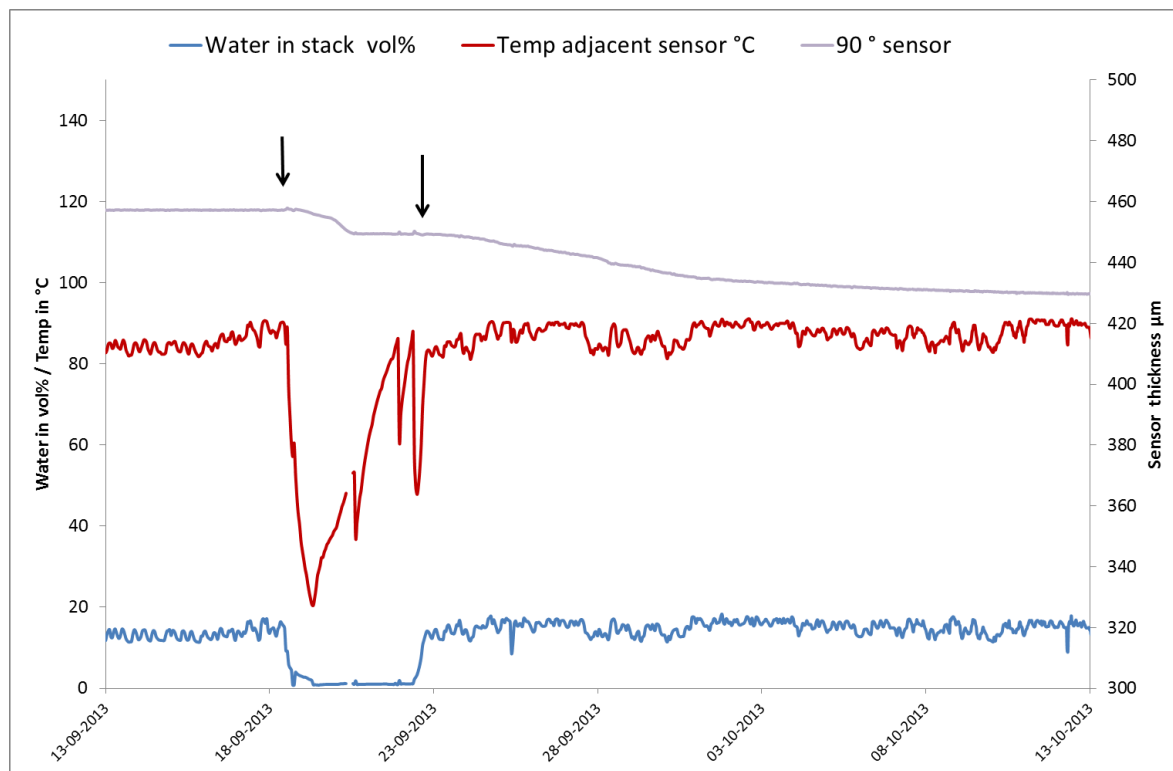
As a consequence of corrosion in the FGCS after only two years operation, various corrosion products and deposits were analysed, and on-line corrosion monitoring was installed. An example of the on-line monitoring is shown in Figure 10 where the sensor thickness decreases

(right hand y-axis) when temperature changes as the FGCS is started up and shutdown. By correlating operation data with on-line sensor thickness just after the GGH, it was clear that corrosion was linked to start-up and shutdowns. The first arrow indicates shutdown and therefore downtime corrosion and the second arrow is plant start-up which also gives rise to corrosion. The corrosion during start-up was observed to decrease when firing only with wood pellets compared with straw pellets. Further detailed results are given in references 5 and 6.

Figure 10: Correlation of reduction in sensor thickness and operation parameters temperature and water content.

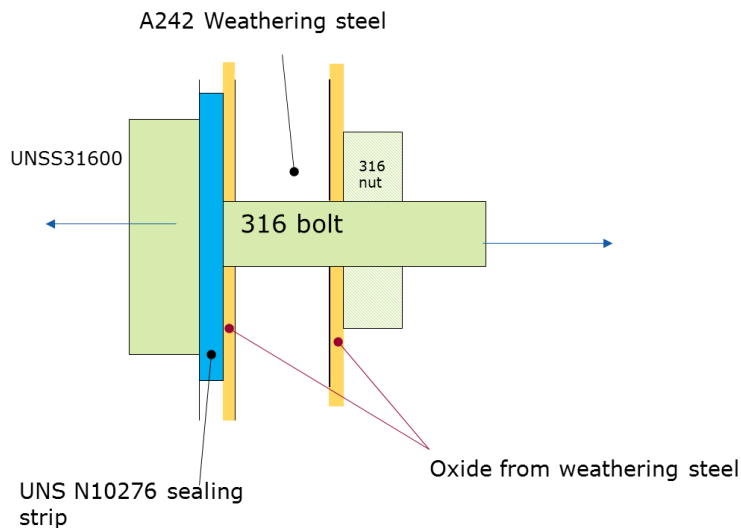
The UNS N10276 sealing strips suffered almost no corrosion in this environment; however their detachment occurs because UNS SS31600 bolts rupture. These bolts revealed transgranular cracking in locations where there were high corrosion rates of the weathering steel rotor and chlorine was present within the cracks. In areas where there was less corrosion of the weathering steel, the bolts exhibited pitting corrosion. Due to the thick oxide formed on the weathering steel in these areas, the bolts are subjected to increasing tensile stress during exposure as 2 mm of steel is replaced by an oxide layer with a 2-3 times greater volume on either side in a period of 2 years. The presence of chlorine via the flue gas and the tensile stress results in rupture as stainless steels have a high sensitivity to stress corrosion cracking. Figure 11 is a schematic showing how the bolt is subjected to tensile stress on both sides as shown by arrows, resulting in fracture.

Figure 11: Schematic diagram showing how tensile stresses can occur for the AISI 316 bolt.

Stress corrosion cracking tests at 43°C, 85°C and 120°C for AISI 304 and 316 steel revealed that failure occurred at 43°C and not at 85°C or 120°C[11]. As expected AISI 304 was more susceptible to SCC than AISI 316 steel. Another study on SCC of AISI 304 steel revealed that SCC occurred to a greater extent at 45°C and 60°C compared to 30°C. From these results the temperature range of 43-60°C is most critical and this is within the temperature range of the lower part of the GGH. In addition a relative humidity of 60% results in a higher susceptibility to cracking at 45°C and 60°C compared to 100%[12]. Thus relative humidity was also a contributory factor where a semi moist environment is more critical than if the component was fully immersed. Yang et al [13] measured the corrosion current of both carbon steel and 316 stainless steel at 50°C under KCl salt with increasing humidity. It was found that by increasing the humidity, the corrosion rate increased uniformly for the carbon steel (i.e. relevant for CORTEN) however for the 316 steel, the corrosion current increased drastically at 70% relative humidity. In both cases the corrosion current increased with increase in relative humidity to 95%. Thus where there was less corrosion of the weathering steel, the bolts were attacked by pitting corrosion and therefore there would be a longer time to failure. In these areas, the humidity was probably lower perhaps due to a decrease in humidity and entrained water droplets. These bolts were replaced with UNS N10276 bolts in the vulnerable locations resulting in no further failure of bolts. Later, the plant was rebuilt so the FGD could be bypassed when only biomass was used as a fuel. Thus during operation, the temperature of the lower part of the GAFO was higher than 50-80°C and therefore above the dewpoint of HCl and water. This reduced corrosion of the weathering steel rotor immensely.
